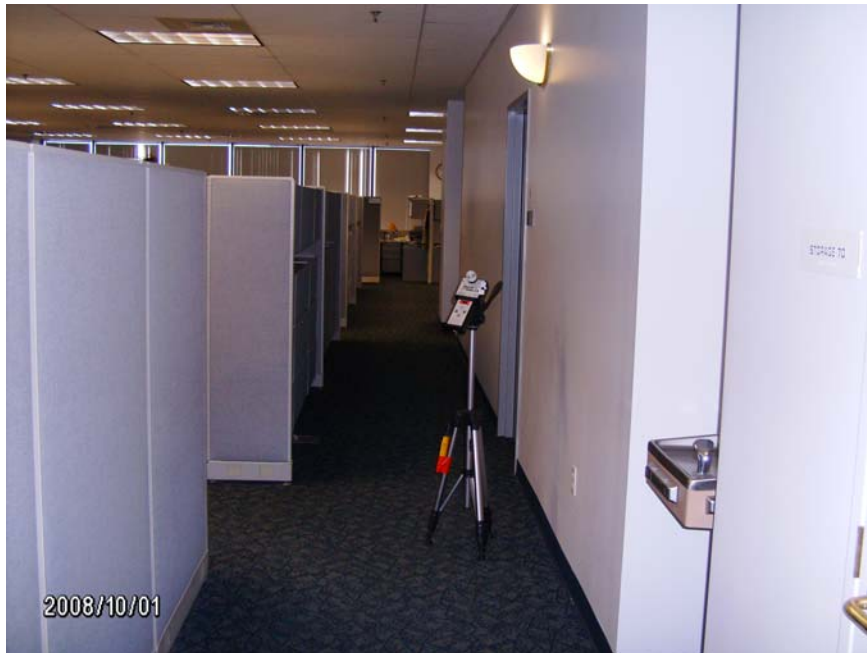
- 1) Image of hallway within BOE occupied working spaces located adjacent to 707 Break Room Area at time of assessment.

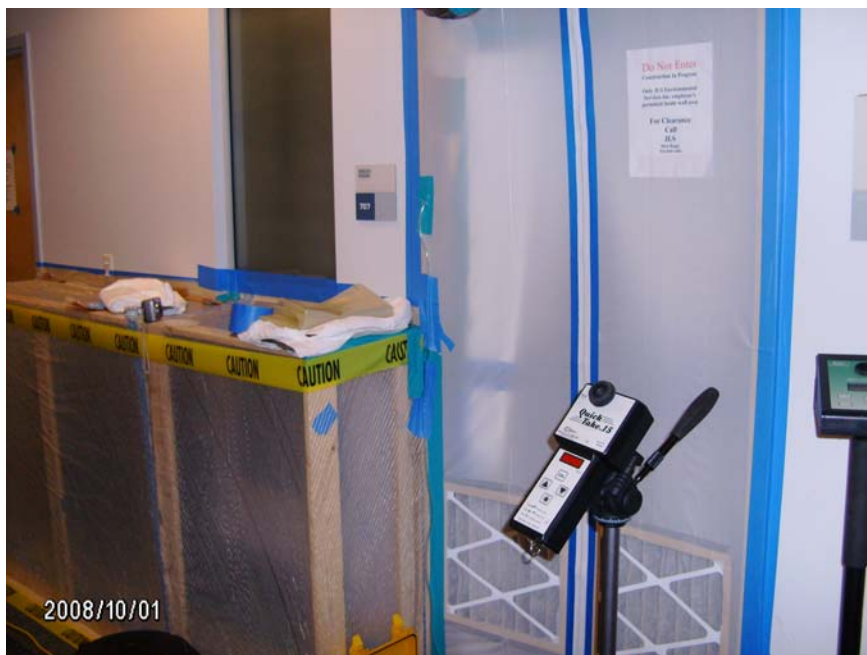
- 2) Image of Break Room 707 containment as viewed from occupied hallway at time of clearance assessment.

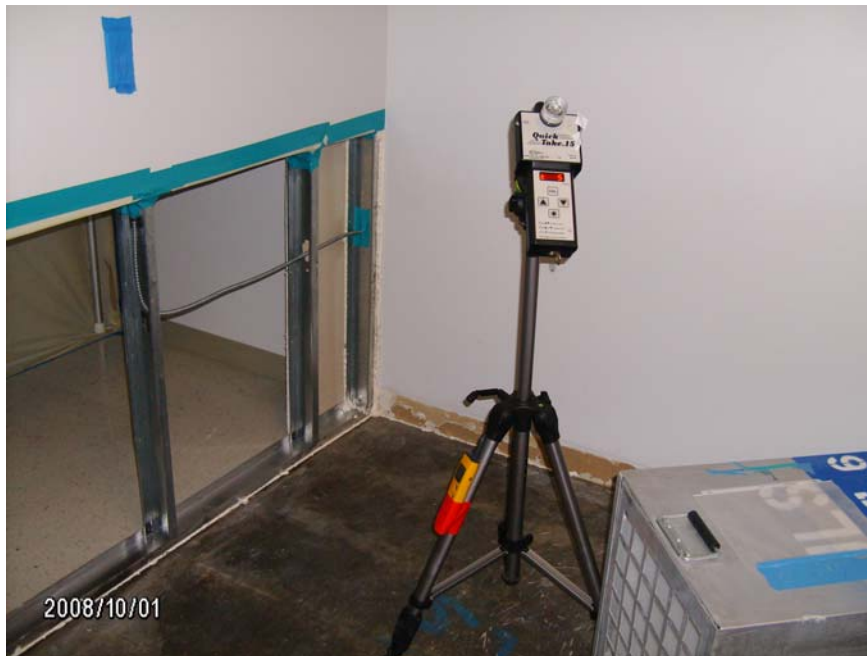
- 3) Image of air sampling equipment and wall removal within Break Room 707 area at time of assessment.

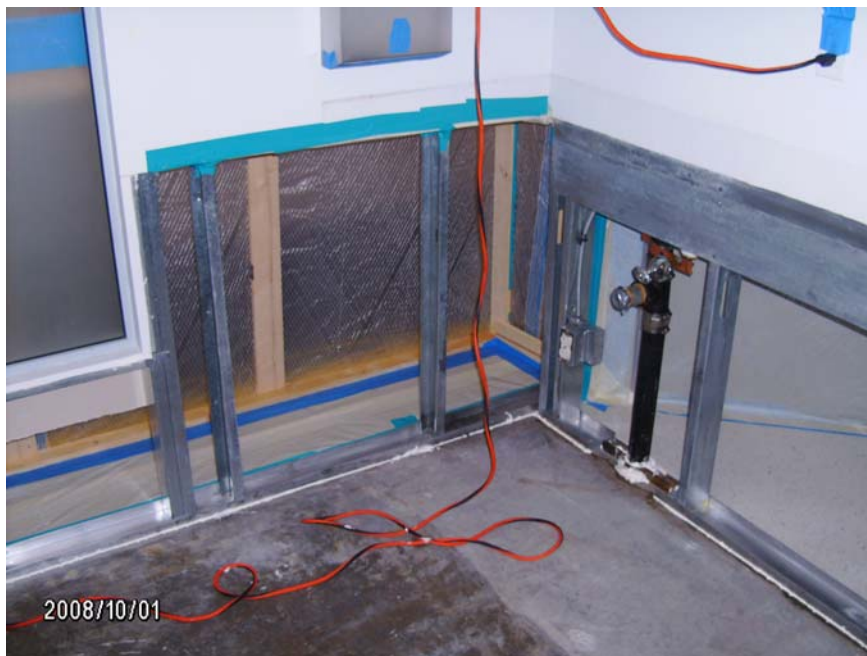
- 4) Image of exposed wall cavity, exposed plumbing, and delineation of wallboard removal within Break Room 707 at time of assessment.

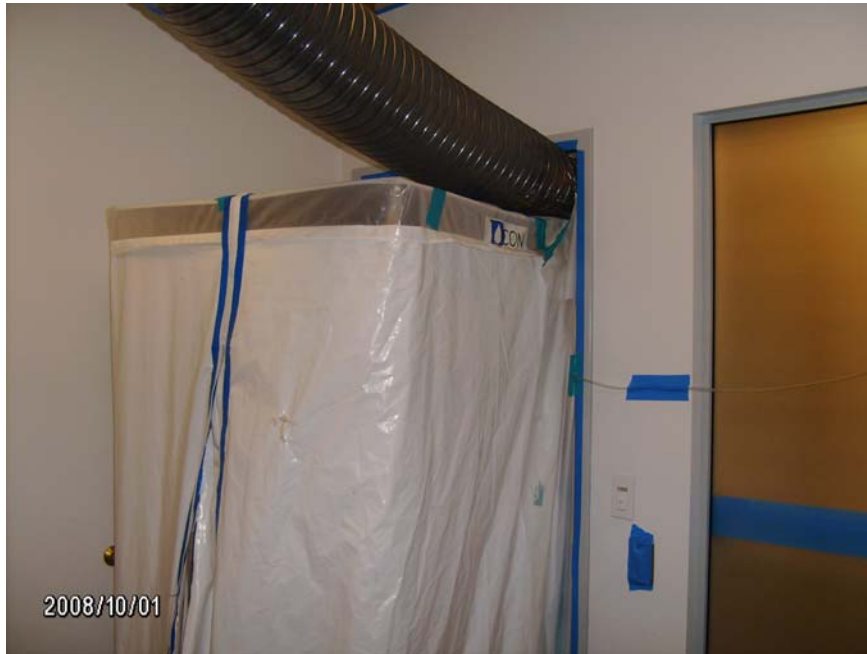
- 5) Image of interior containment entry chamber and flex exhaust HEPA ducting within Break Room 707 at time of assessment.

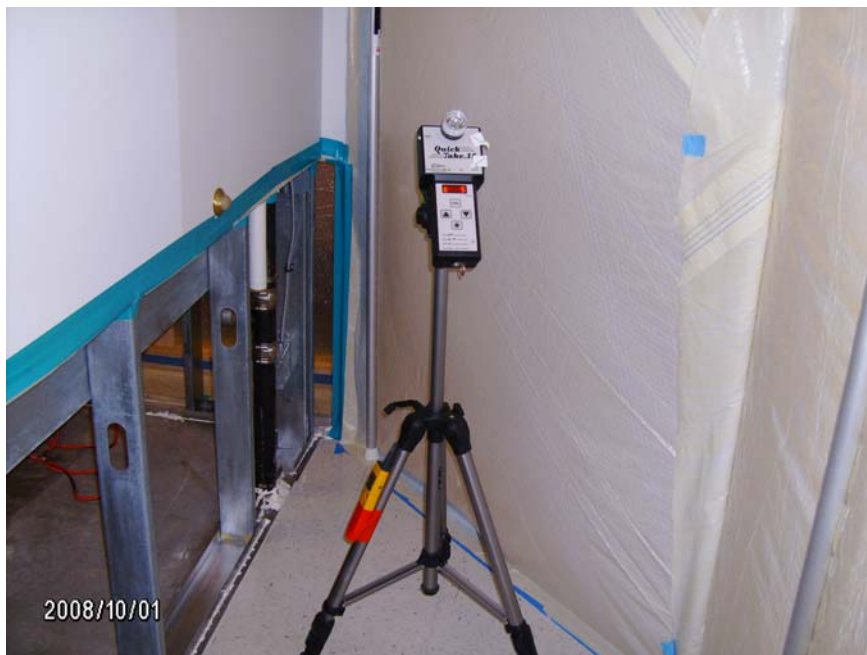
- 6) Image of wallboard removal delineation within adjacent supply room area at time of assessment.

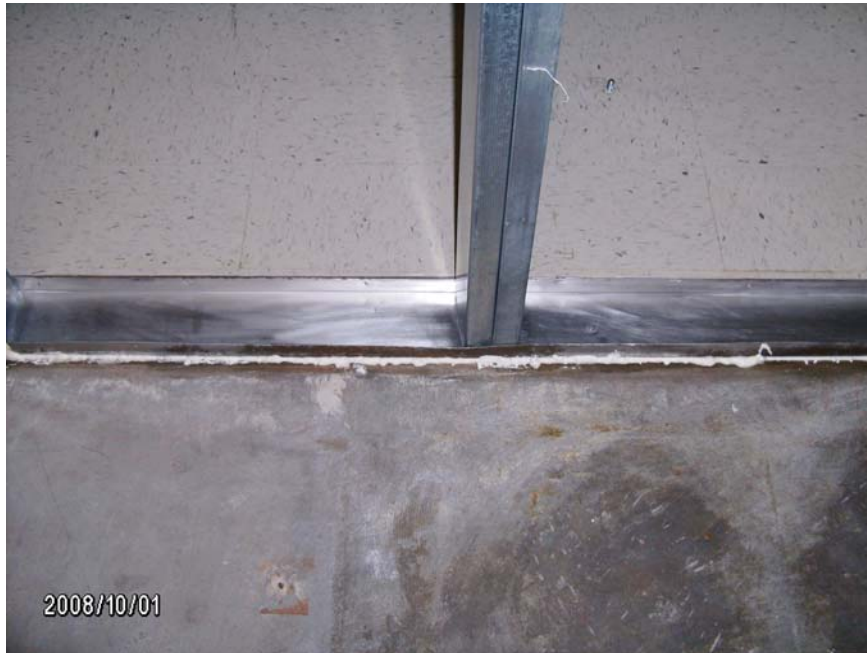
- 7) Close up image of exposed floor sill metal framing following mitigative cleaning as viewed from Break Room 707 at time of assessment.

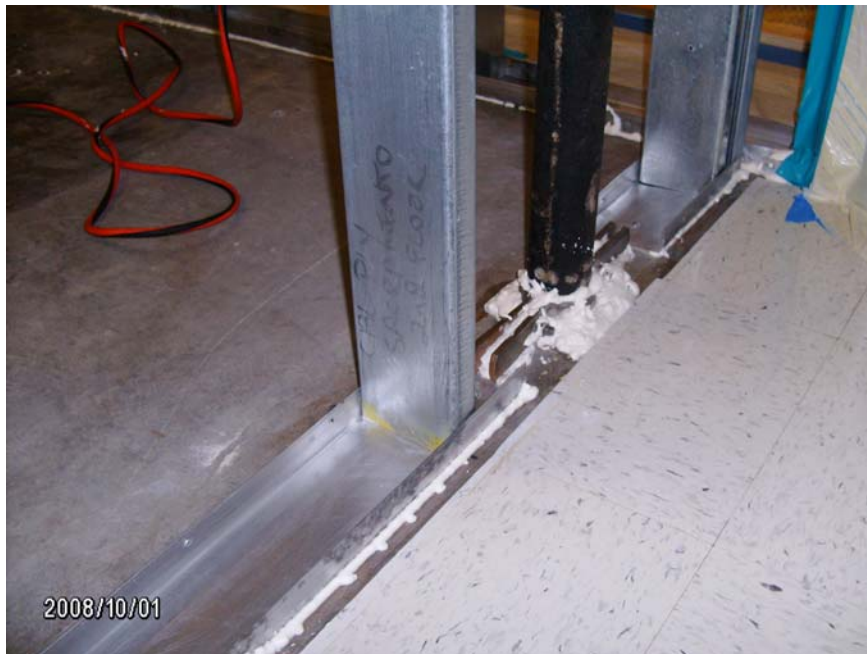
- 8) Image of exposed metal wall framing and plumbing systems as viewed from adjacent supply room at time of assessment. .

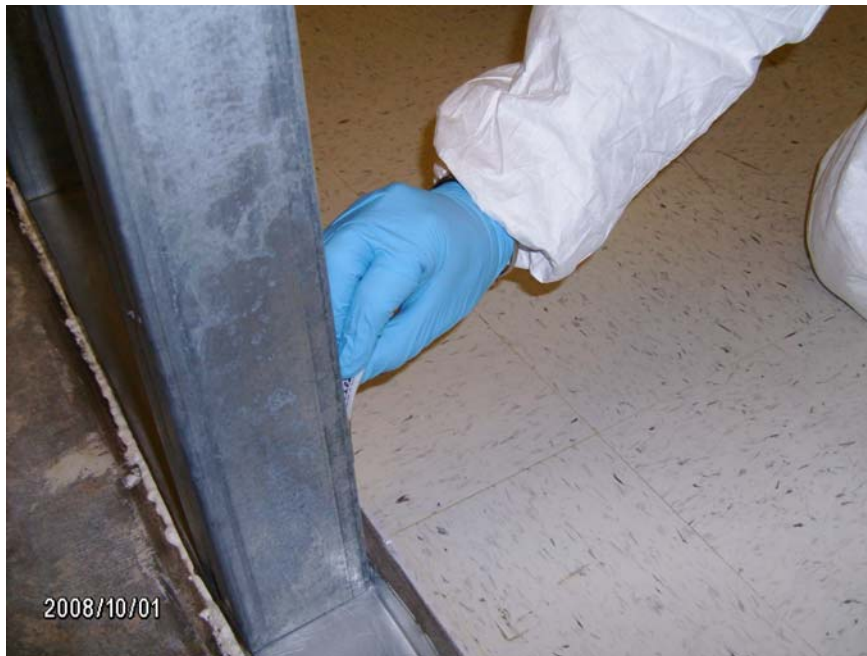
- 9) Close-up image of HTI technician collecting surface sample of metal framing surface within supply room at time of assessment.

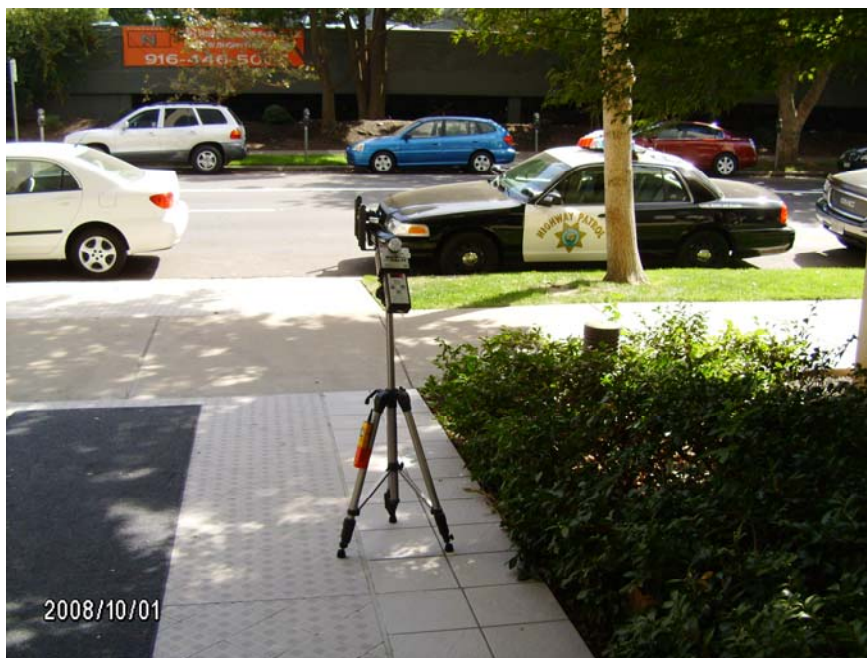
- 10) Image of ambient air sampling equipment location performed at conclusion of interior sampling activities.
